SPE 107069

Rigless Tubing Repair Using Permanent and Retrievable Patches at Prudhoe Bay, Alaska—Continued Analysis and Current Applications

J.Y. Julian, SPE, and D.A. Cismoski, SPE, BP (Alaska) Inc., and J.K. Sack, SPE, Petrotechnical Resources of Alaska Inc.

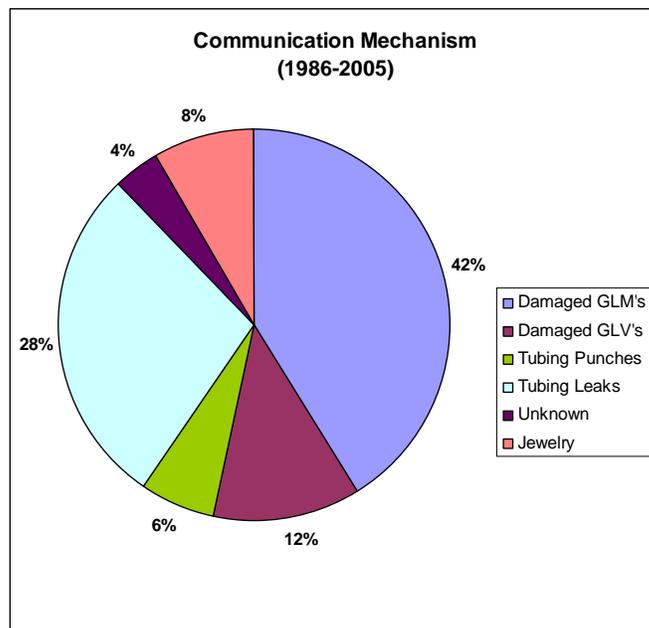
Initially, the primary cause of tubing by "A" annulus communication at Prudhoe Bay was due to problems associated with gaslifting operations. Sixty percent of the patched wells have had communication problems associated with gaslifting, including damaged GLM's, broken or stuck gaslift valves (GLV's), and tubing punch isolation. As the field matured, failure became increasingly due to corrosion and 28% of the patches were set to isolate tubing holes. Figure 4 describes the most common causes of communication repaired with tubing patches.

Figure 4. Annular communication mechanism for all patches set from 1986-2005

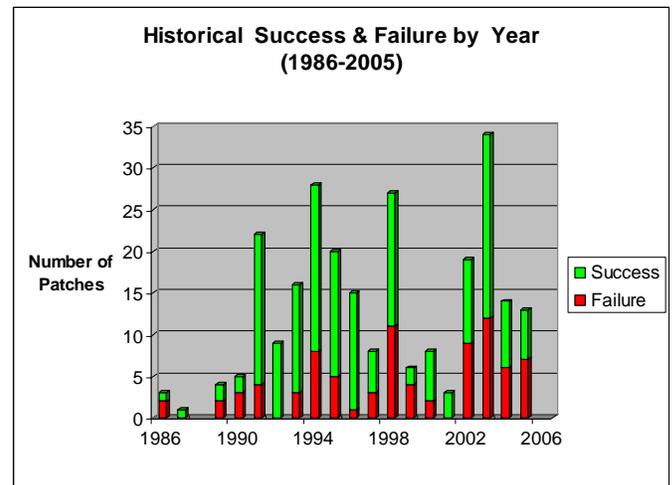
Historical patch failure analysis. The number of patches and success rate has varied considerably over the years (Figure 5). The average is 15 patches set per year with an approximate 70% success rate.

Figure 5. Historical patch success and failure for all patches by year (1986-2005).

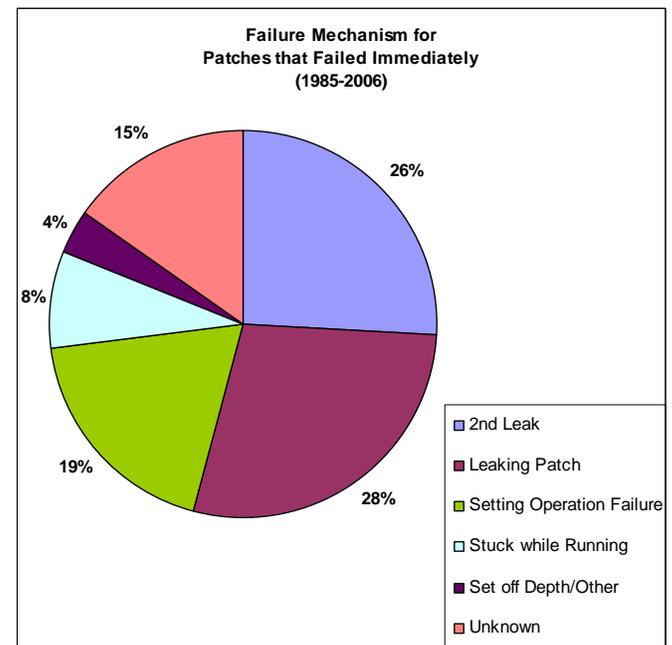
Immediate failure. The most common reason that patches fail immediately is a leak in the patch (28%) or a second leak (26%) detected by running a post-patch LDL (Figure 6).

Figure 6. Failure mechanism for patches that failed immediately (1986-2005).

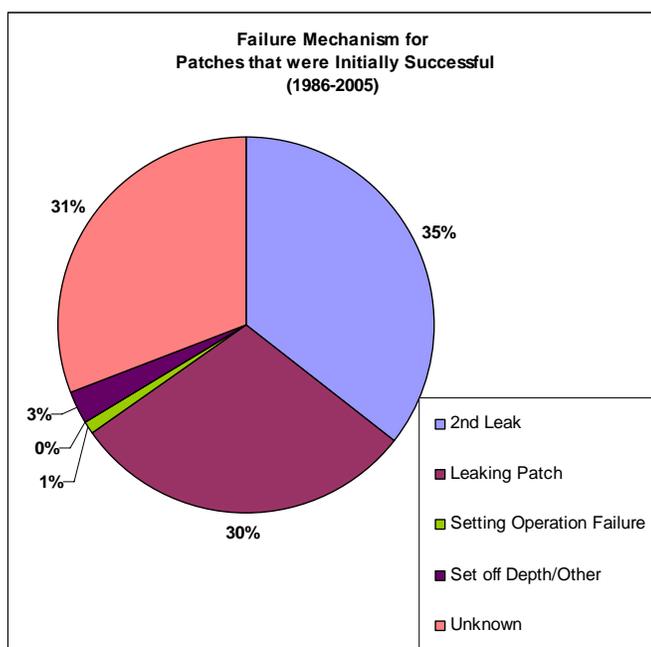
Failure after the patch is initially successful. The most common root causes for patch failures that initially had integrity are 2nd leak failures (38%), leaking patches (30%), and unknown causes (31%) (Figure 7).

Figure 7. Failure mechanism for patches that were initially successful, but subsequently failed (1986-2005).

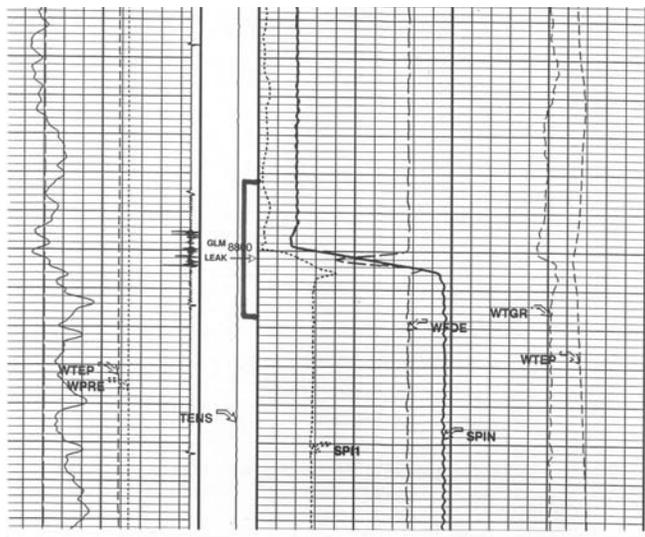
Although memory LDL's are less expensive, real-time LDL's are preferred due to the advantages of on-the-fly procedural changes. Repeat passes of anomalies can be important to ensure accurate leak identification. Log presentation should include identifying jewelry so that the log can be used for patch tie-in (Figure 8).

Figure 8. Leak detection log showing leak at gas lift mandrel. Pumping down the "A" annulus taking returns down the tubing into the formation.

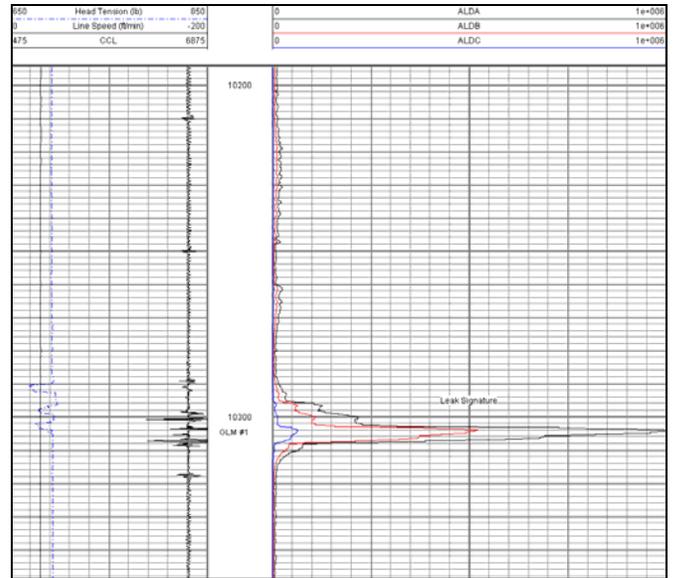
Figure 9 shows a GLM leak identified by the ultrasonic noise detection log. Approximately 30 jobs have been performed to date using this new commercially available technology. It is preferable to conventional leak detection logs because of its sharp delineation. However, it currently cannot detect leaks larger than 1 bbl per minute.

Figure 9. Ultrasonic noise log showing leak at gas lift mandrel. The leak rate ranged from approximately 0.16 to 0.025 gpm.

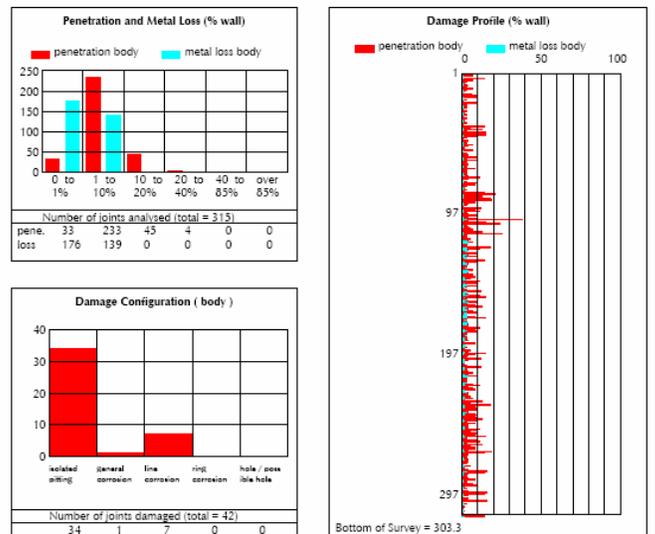
Figure 10. Multi-Finger caliper tabulated joint damage report.

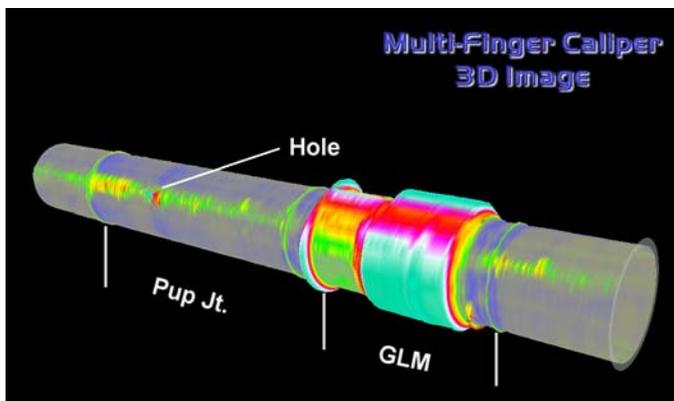
Figure 11. Caliper Survey showing hole in pup joint below GLM.

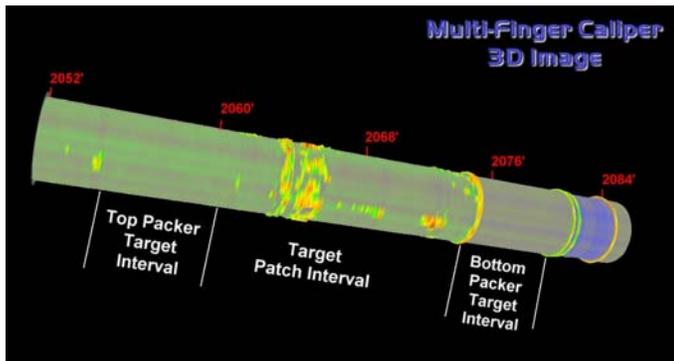
Figure 12. Caliper survey showing target patch location.

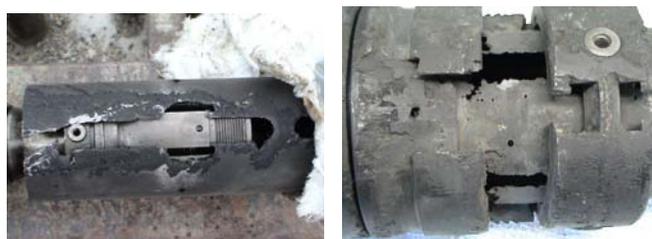
Patch retrieval. Retrievable patches can usually be retrieved with slickline or braided line using conventional fishing tools, weight bar, oil jars, and spang jars. Patch retrieval has not generally been a problem at Prudhoe Bay although often braided line is required. Rarely, CT has been used. Often the patch elements are stripped off at nipple profiles and other restrictions and must be fished out separately. It is important to allow a recommended minimum “element relaxing time” of approximately 45 minutes prior to starting out of the hole after the patch has been released. Pumping cold fluid to shrink the elements has also been used occasionally with success. Fishing neck erosion and corrosion (Figure 13) can occur. requiring the need to set a releasable spear for fishing, however, generally fishing operations are successful.

Figure 13. Corroded tubing patches
